THE REBUILDING AND REPAIRING OF
ELECTRIC MOTORS AND GENERATORS.

A THESIS SUBMITTED TO THE FACULTY OF THE SCHOOL
OF ENGINEERING OF THE UNIVERSITY OF KANSAS.

R. E. RIDNOUR

1 9 1 8.

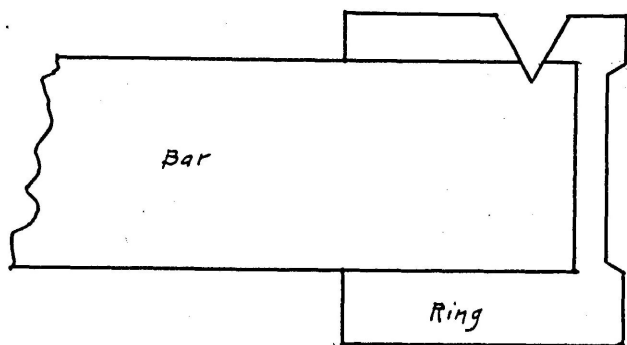
Figure #1.

The rotor was removed from the motor, mounted in a lathe, and a channel cut in the short circuiting rings (See Figure #1). The operation was watched very closely and when the cut had reached the end of the bars a layer of black substance resembling carbon was found to have coated the bars where they were supposed to be thoroughly fused to the bronze ring. The coating was thickest on the bars in which the discoloration of the copper showed the most heat had been developed. A few of the bars had heated very little and on these the coating was found to be very light.

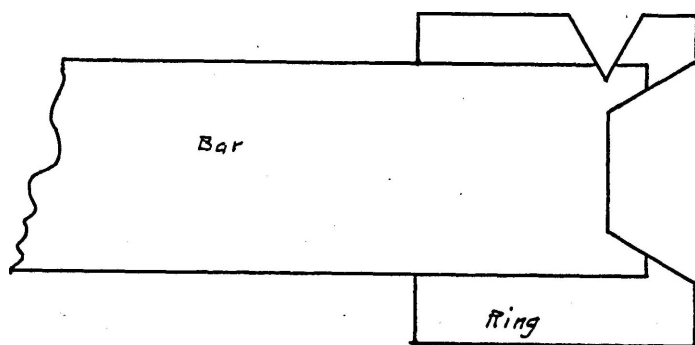
Figure #2.

The cut was continued to a depth that assured a surface of contact equal to the cross sectional area of the bar. (See Figure 2). The ring was of varying thickness and the ends of the bars were not in line so that in order to secure a good contact surface on all the bars it was necessary to cut very deep into some of them and to cut entirely through the ring on the side where it was thinnest. After a channel had been cut in each ring the rotor was removed from the lathe and stood on end. Fire clay was built up around the ring and the channel in the ring thoroughly brazed with a welding flame of oxygen and acetyline gas. After this the channel was welded full of Tobin bronze.

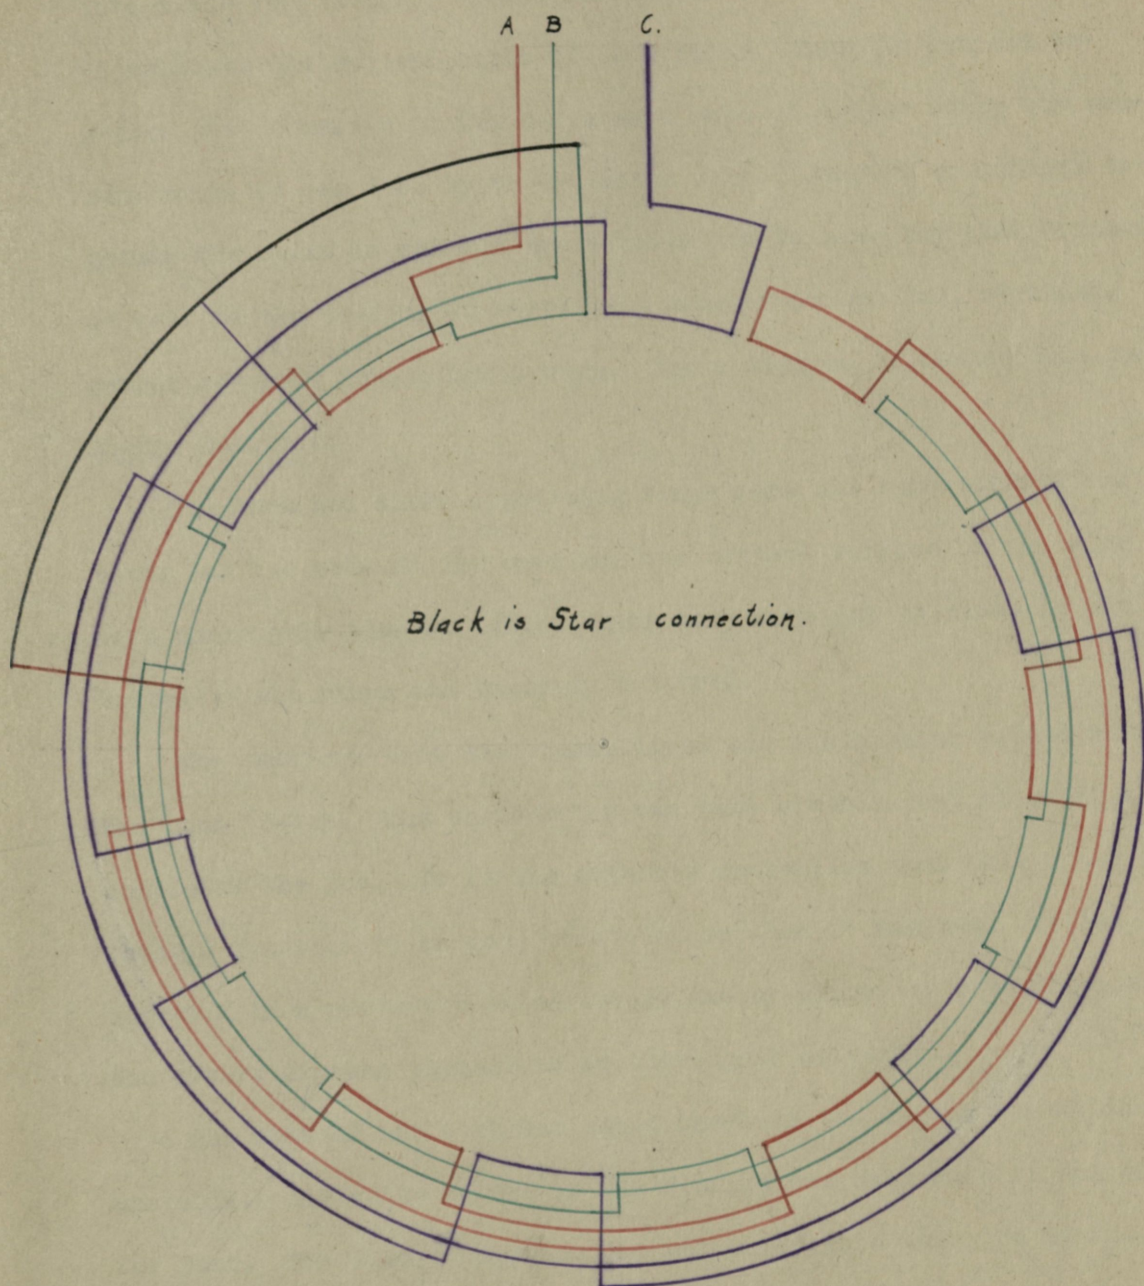
Figure #4.

Connection diagram of 100 H.P. A.C. motor.

into place very snugly. Phase insulation of treated canvass was used to separate the two end coils of each phase. Lugs to connect together the terminals of the coils were made of copper strip six one-hundredths by one inch by three inches long. Jumpers to connect together the coils in the different poles and to make the star connection as well as the leading in wires were made of number two, stranded, rubber covered, double braid wire. For a diagram of connections see Figure Number 4.

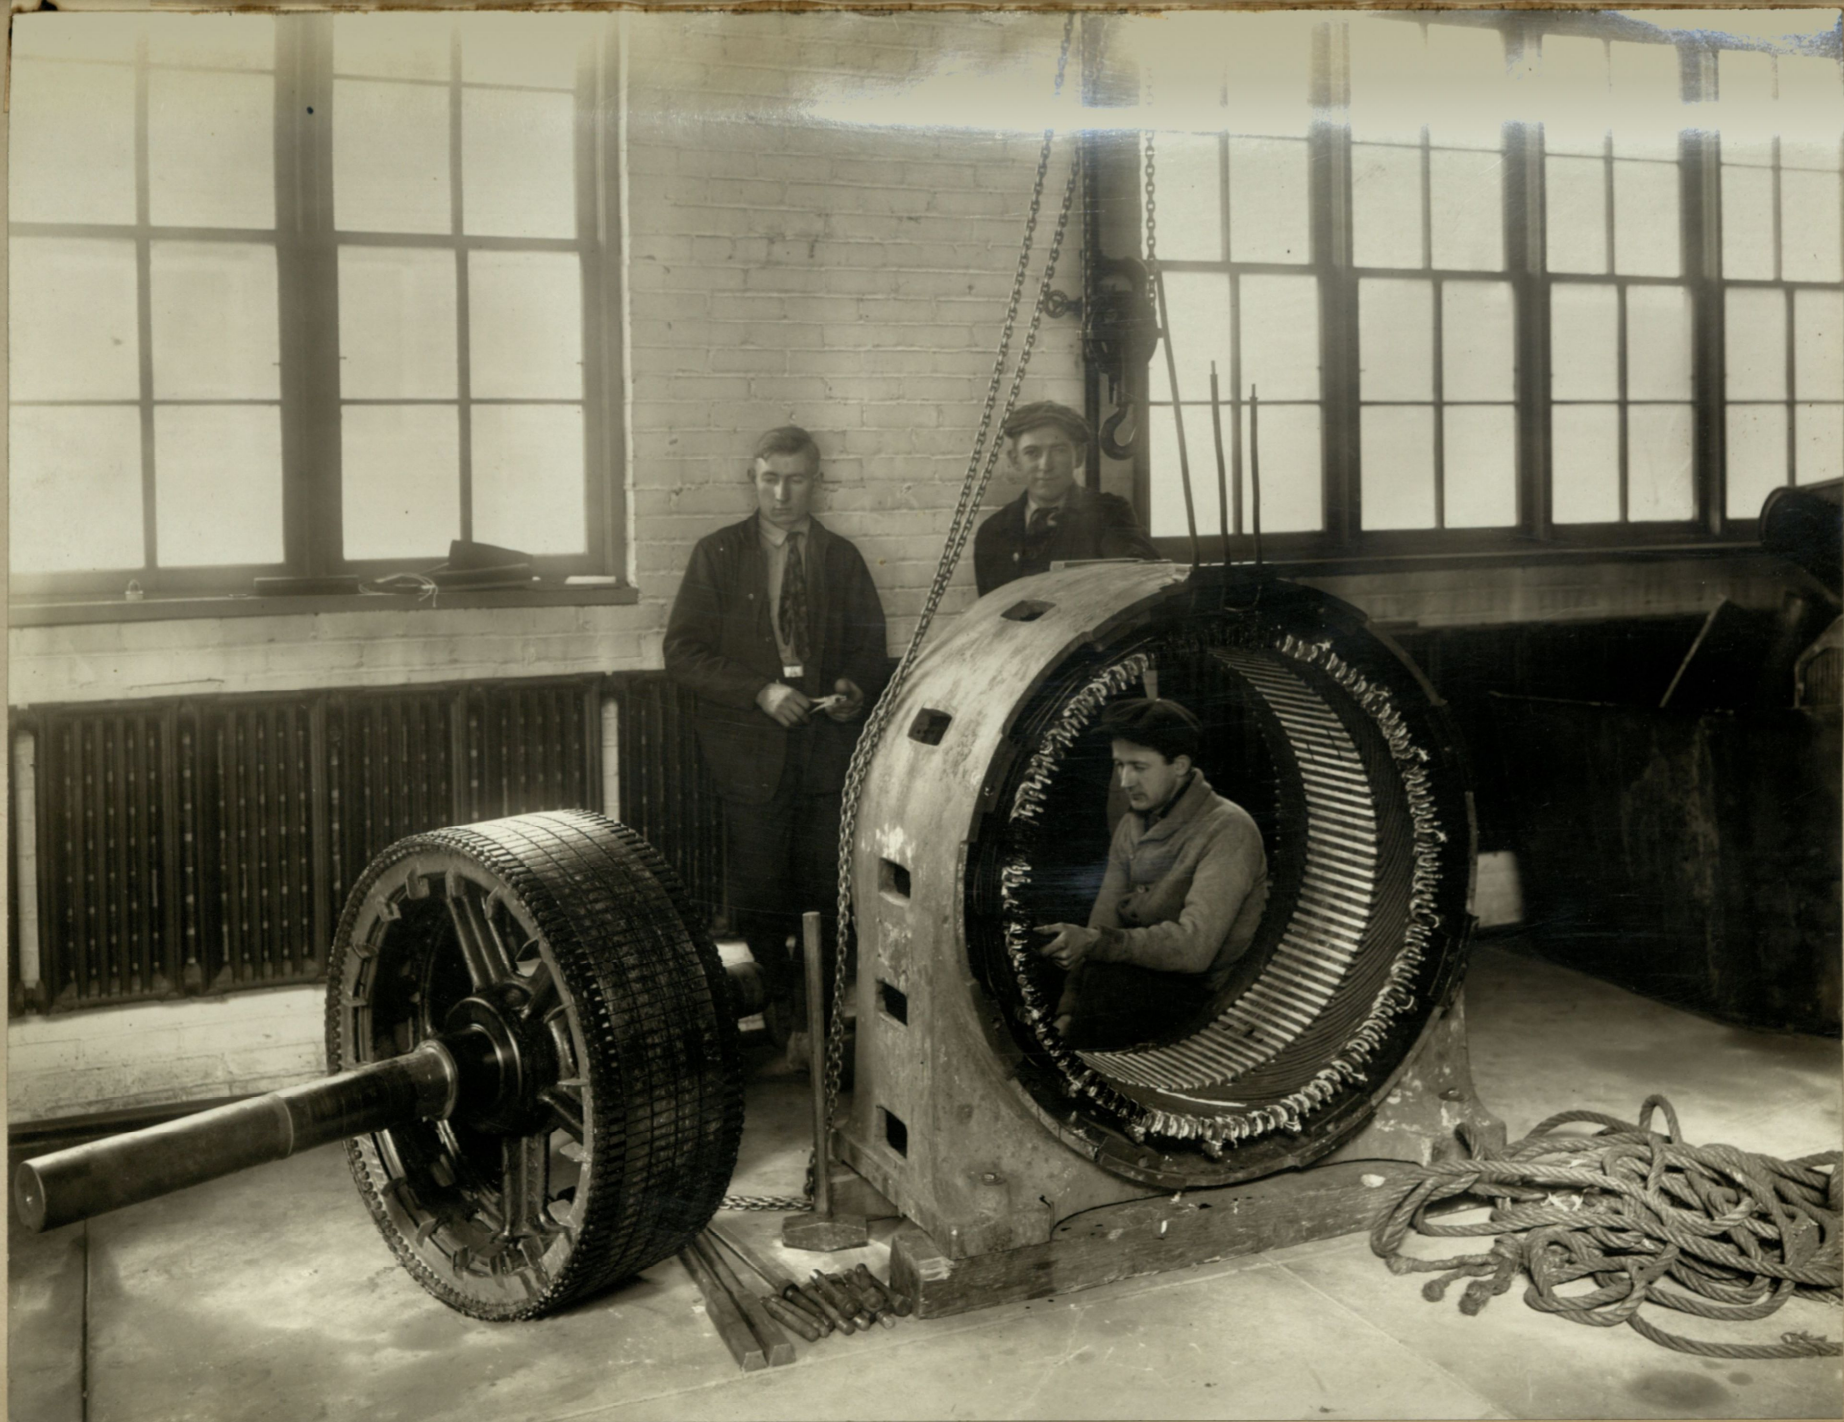
Figure Number 5 is a photograph of this motor just after the coils had been put back in place and re-connected.

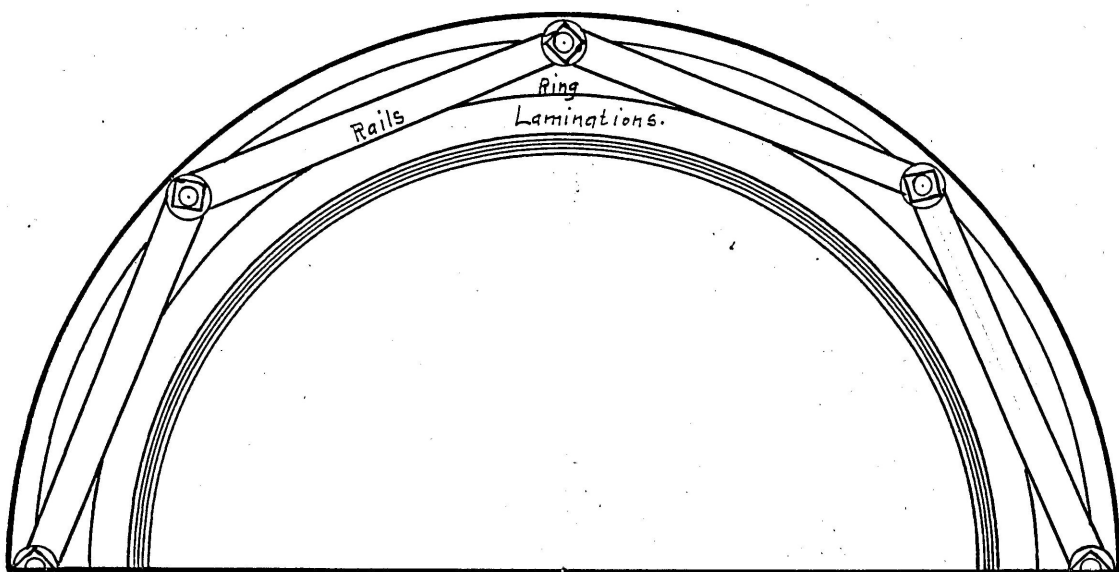
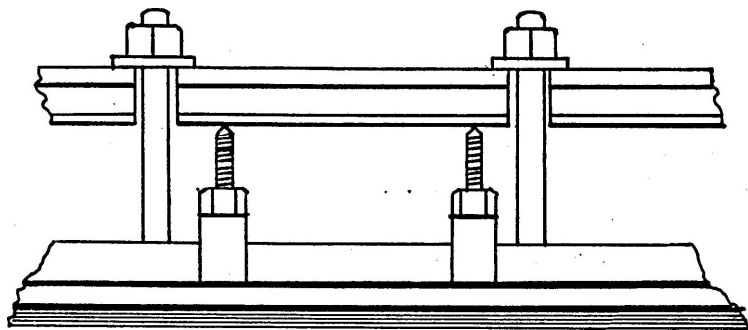
Figure 3.

Shaded portion indicates slots.

In spite of all the care that was used in straightning the laminations and putting them back in place some difficulty was experienced in re-placing them all back in the stator. A rigging of rails of a weight commonly used for mine tracking was built up around the stator held in place by bolts screwed into the housing bolt holes. From under these rails small improvised jack screws were used (See Figure 3) on all sides of the stator at the same time forcing the laminations down in place. A little filing with a sixteen inch mill file was all that was needed to make the sides of the slots smooth. When the laminations had been secured in place by inserting the ring and key provided for that purpose and given a coat of air drying insulator the stator was ready to receive the coils.
